**Flood Control Project Maintenance  
Levee Inspections**

## 2019 Channel Summary Report

## Merced Streams Group

**Levee Inspection Report By Mile - Channel 2019**

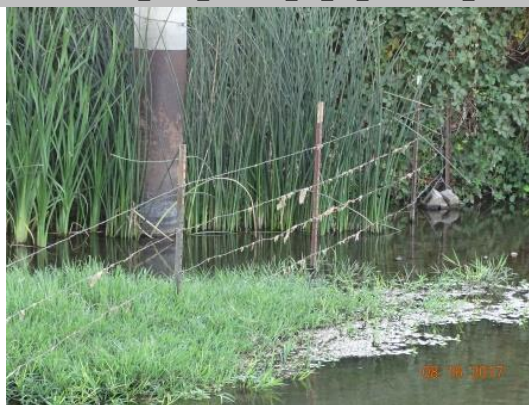
Photo 2 of 2 : CH\_2019\_NA0013\_32\_10\_20190722\_00006.jpg

View of the fence in the channel. Summer 2017

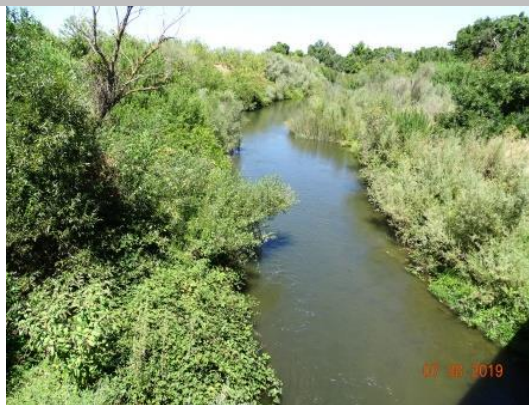
Photo 1 of 1 : CH\_2019\_NA0013\_32\_26\_20190808\_00068.jpg

Inspector Comments: There is vegetation present on both banks of crossing. Recommend clearing vegetation at least 100ft downstream from the bridge.

View of vegetation looking upstream. Summer 2019

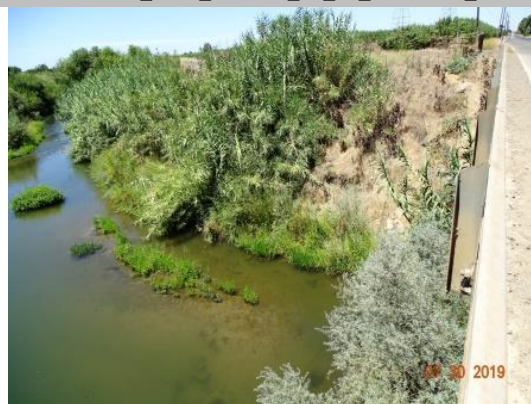
Photo 1 of 3 : CH\_2019\_NA0013\_32\_36\_20190808\_00071.jpg

View of vegetation looking downstream. Summer 2019

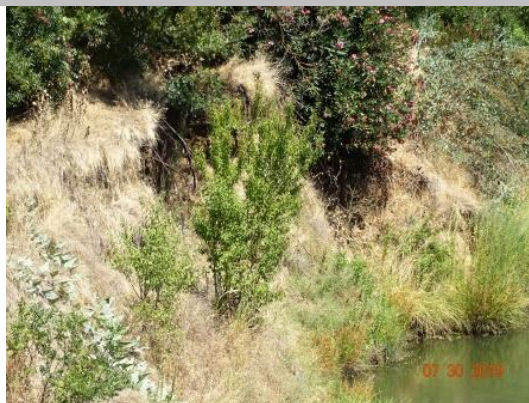
Photo 1 of 3 : CH\_2019\_NA0013\_32\_43\_20190808\_00075.jpg

Rating **	U	Issue No.	43	GPS Lat/Long
Issue Type +	Ma	Location *		37.309600 °
Category	Rivers, Channels & Designated Flood			-120.444500 °
Item	Erosion / Bank Caving			
DWR ID	DWR_NA0013_32_c_2016_43			
Action/Comments				
Inspector Comments: Erosion still present on the right bank upstream of the McKee Rd. Bank should be repaired before Flood Season.

View of erosion on the right bank upstream of McKee Rd bridge.  
Summer 2019

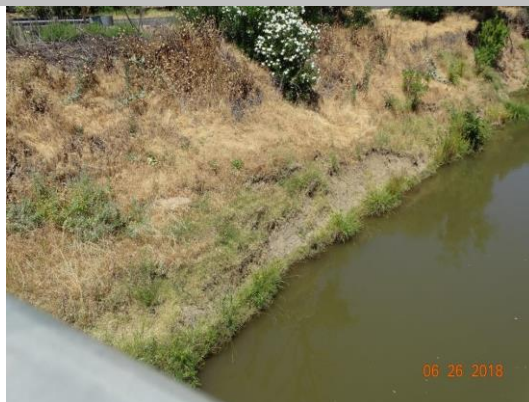
Photo 3 of 3 : CH\_2019\_NA0013\_32\_43\_20190722\_00029.jpg

Inspector Comments: Erosion still present on the right bank upstream of the McKee Rd. Bank should be repaired before Flood Season.

View of erosion on the right bank upstream of the McKee Road bridge.  
Summer 2018

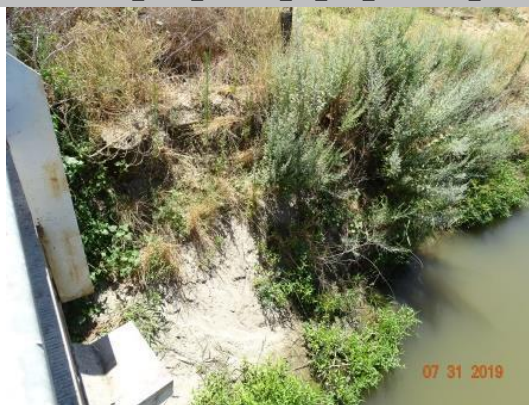
Photo 1 of 2 : CH\_2019\_NA0013\_32\_108\_20190809\_00092.jpg

View of erosion on left bank downstream of the Bert Crane Rd crossing.  
Summer 2019

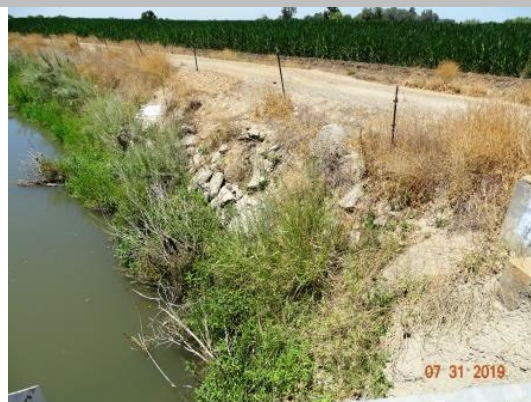
Photo 1 of 1 : CH\_2019\_NA0013\_32\_109\_20190809\_00093.jpg

Inspector Comments: Broken concrete riprap exists on the right bank.

View of broken concrete as riprap on the right bank. Summer 2019

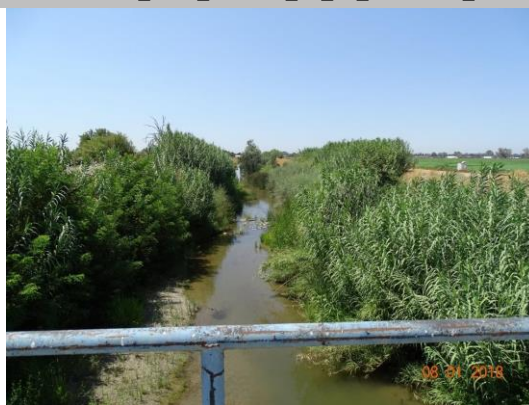
Photo 2 of 2 : CH\_2019\_NA0013\_33\_17\_20190722\_00008.jpg

View of shoaling along left bank. Summer 2018

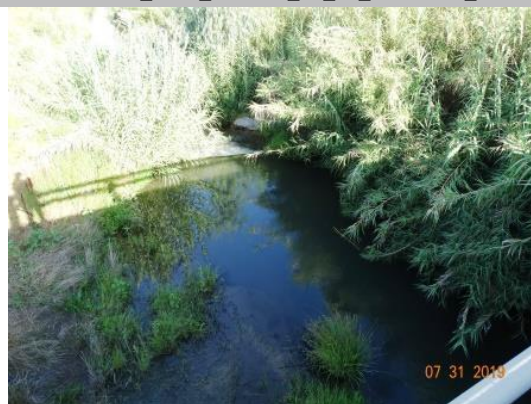
Photo 1 of 3 : CH\_2019\_NA0013\_33\_26\_20190808\_00054.jpg

View of vegetation looking downstream. Summer 2019

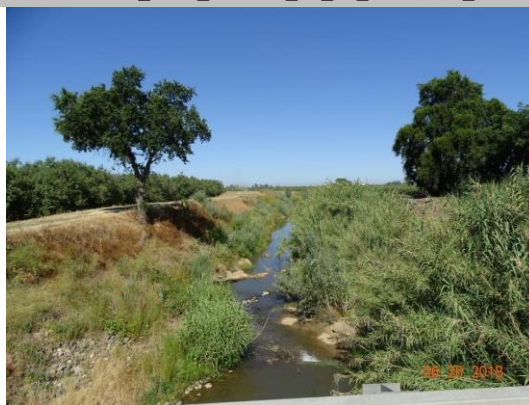
Photo 2 of 2 : CH\_2019\_NA0013\_33\_27\_20190722\_00019.jpg

Black Rascal Creek looking downstream from Franklin Road crossing.  
Shoaling along both banks. Summer 2018

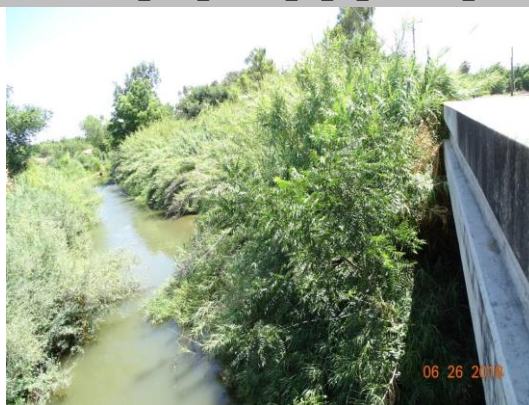
Photo 2 of 2 : CH\_2019\_NA0013\_33\_41\_20190722\_00027.jpg

View of Black Rascal Creek upstream of the Hwy 140 crossing. Overgrown brush adjacent to crossing. Summer 2018

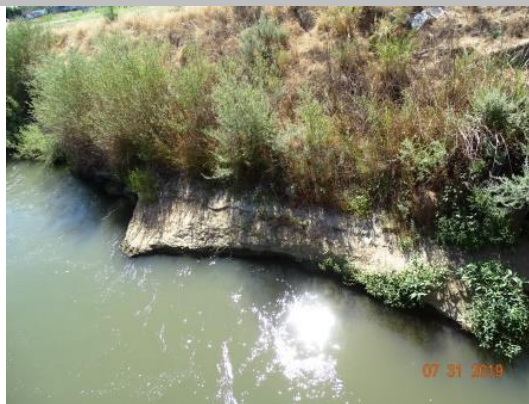
Photo 1 of 1 : CH\_2019\_NA0013\_33\_53\_20190809\_00066.jpg

Rating **	M	Issue No.	53	GPS Lat/Long
Issue Type +	Ma	Location *		37.293797 °
Category	Rivers, Channels & Designated Flood			-120.596922 °
Item	Erosion / Bank Caving			
DWR ID	DWR_NA0013_33_c_2016_53			
Action/Comments				
Inspector Comments: Repair erosion on left bank.

View of erosion on left bank. Summer 2019

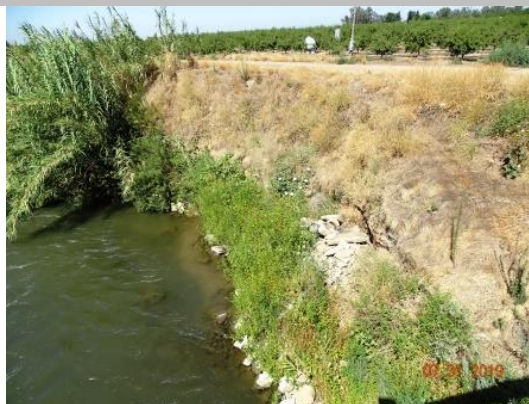
Photo 1 of 2 : CH\_2019\_NA0013\_33\_58\_20190809\_00068.jpg

Inspector Comments: Erosion has been mitigated with broken concrete as riprap.

View of erosion site on the right bank. Summer 2019

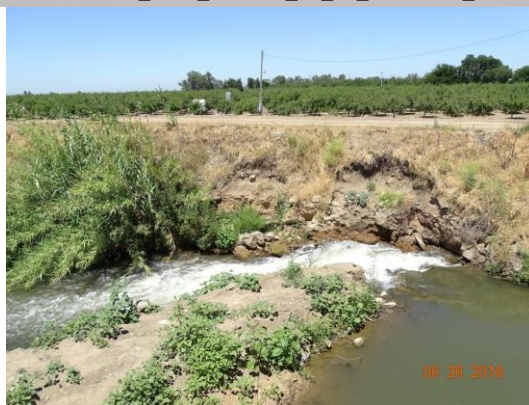
Photo 2 of 2 : CH\_2019\_NA0013\_33\_58\_20190722\_00036.jpg

Significant erosion on right bank downstream of Quinley Rd. crossing .  
Summer 2018

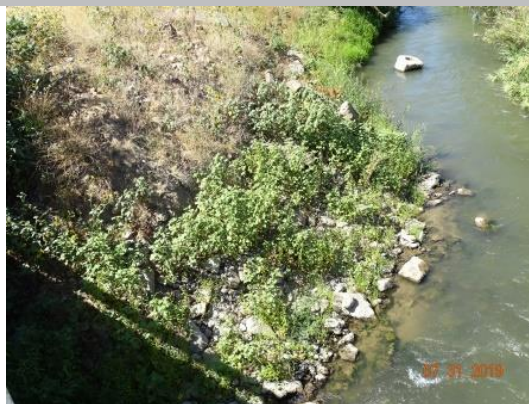
Photo 1 of 2 : CH\_2019\_NA0013\_33\_59\_20190809\_00069.jpg

Inspector Comments: Broken concrete was placed on both banks.

View of broken concrete on left bank. Summer 2019

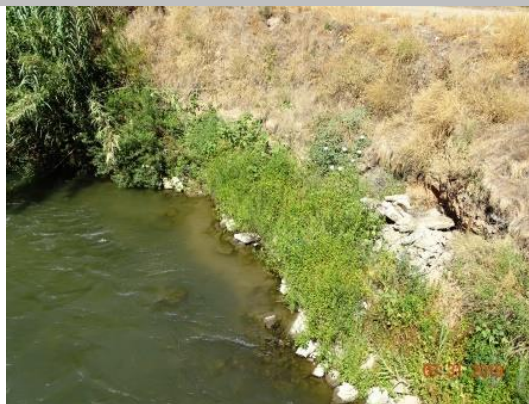
Photo 2 of 2 : CH\_2019\_NA0013\_33\_59\_20190809\_00070.jpg

Rating **	A	Issue No.	59 (cont)	GPS Lat/Long
Issue Type +	Ma	Location *		37.293797 °
Category	Rivers, Channels & Designated Flood			-120.596922 °
Item	Revetments			
DWR ID	DWR_NA0013_33_c_2016_59			
Action/Comments				
Inspector Comments: Broken concrete was placed on both banks.

View of broken concrete on right bank. Summer 2019

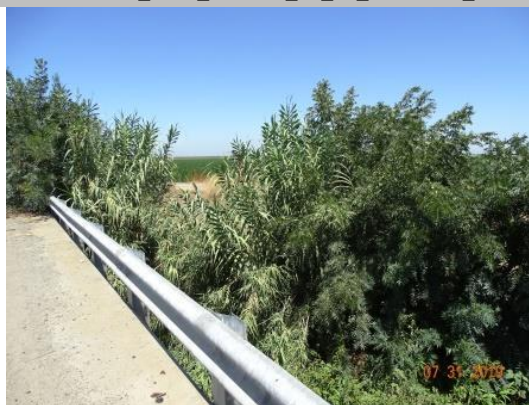
Photo 2 of 2 : CH\_2019\_NA0013\_33\_61\_20190809\_00072.jpg

Black Rascal Creek from Oak Avenue crossing. Overgrown brush adjacent to crossing. Summer 2019

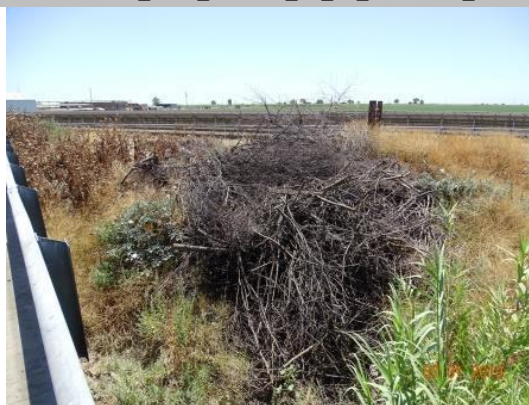
Photo 1 of 1 : CH\_2019\_NA0013\_33\_70\_20190809\_00074.jpg

View of prunings on left bank downstream of bridge. Summer 2019

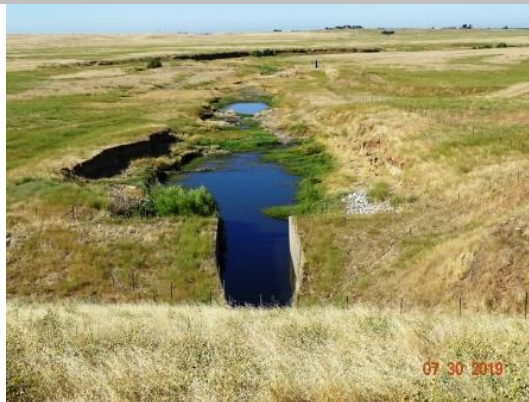
Photo 1 of 2 : CH\_2019\_NA0013\_34\_6\_20190807\_00013.jpg

View of vegetation at the Burns Creek Dam outlet. Summer 2019

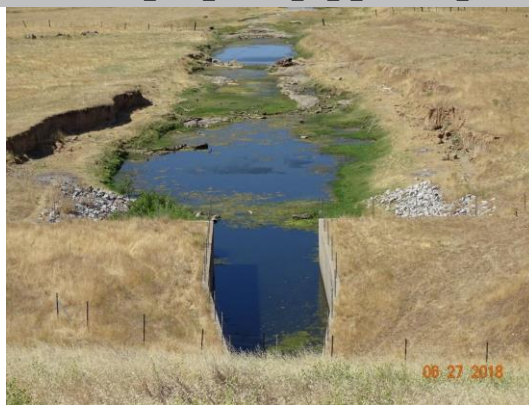
Photo 2 of 2 : CH\_2019\_NA0013\_34\_6\_20190722\_00001.jpg

View of vegetation at the Burns Creek Dam outlet. Summer 2018

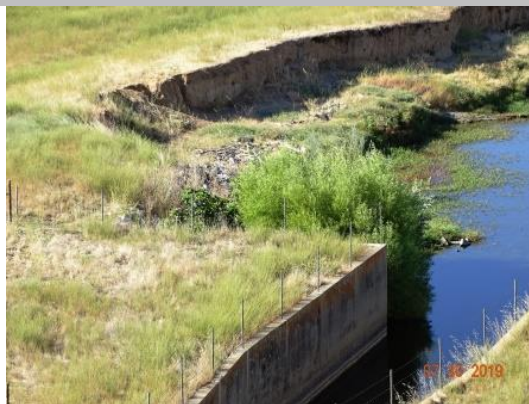
Photo 1 of 2 : CH\_2019\_NA0013\_34\_8\_20190807\_00014.jpg

Historic erosion on the left bank at the Burns Creek Dam outlet. This erosion does not appear to be active. Summer 2019.

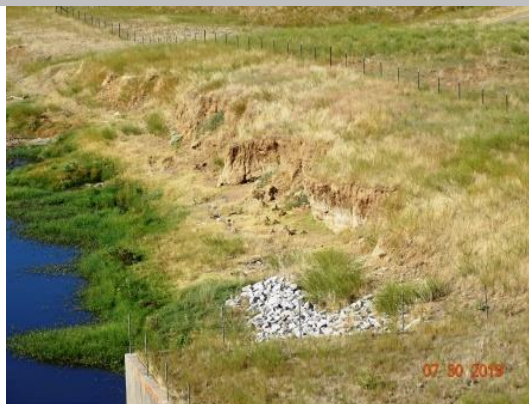
Photo 2 of 2 : CH\_2019\_NA0013\_34\_8\_20190807\_00015.jpg

Historic erosion on the right bank at the Burns Creek Dam outlet. This erosion does not appear to be active. Summer 2019

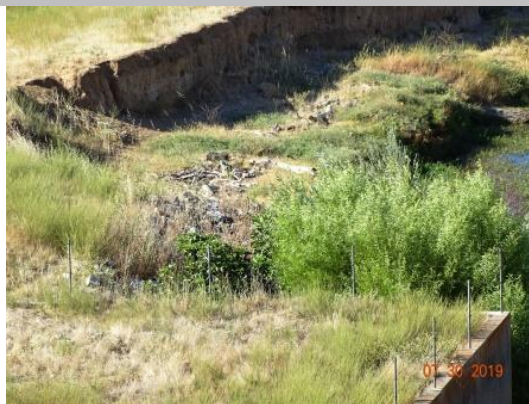
Photo 1 of 2 : CH\_2019\_NA0013\_34\_9\_20190807\_00016.jpg

View of revetment on left bank downstream of Burns Creek Dam.  
Vegetation growing in riprap. Summer 2019

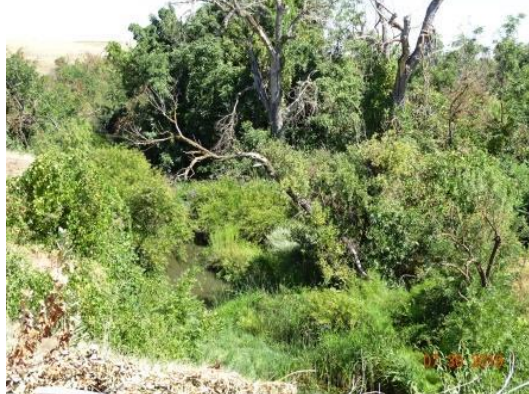
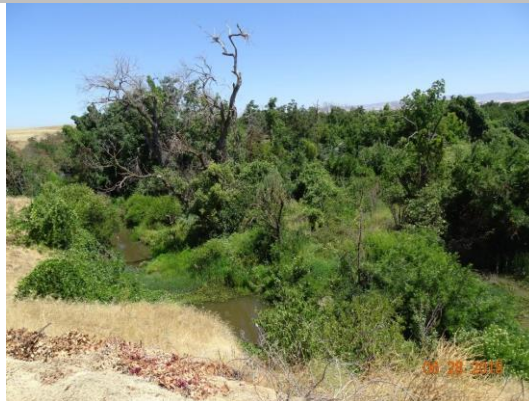
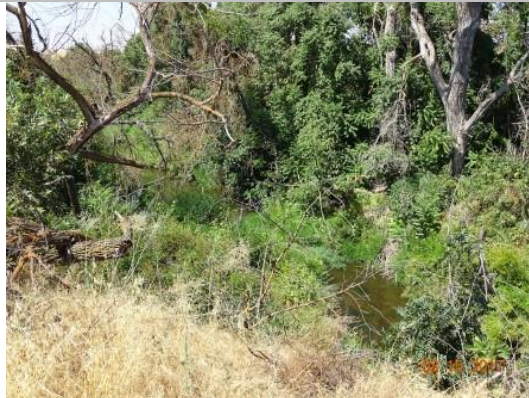
Inspector Comments: Access to this location via the right bank requires notification of the property owner. Vegetation on Burns and Bear Creeks was never maintained and needs to be controlled or removed.

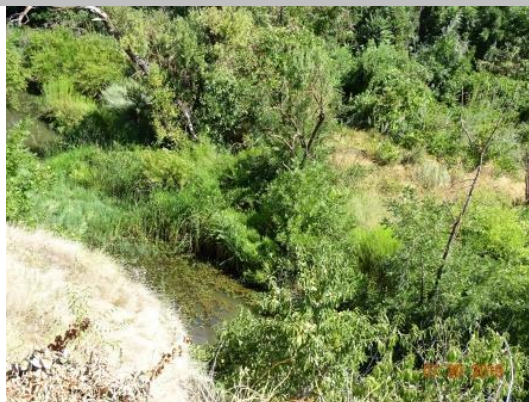
Photo 1 of 3 : CH\_2019\_NA0013\_34\_22\_20190807\_00021.jpg

View of shoal connecting banks of Burns Creek. Summer 2019

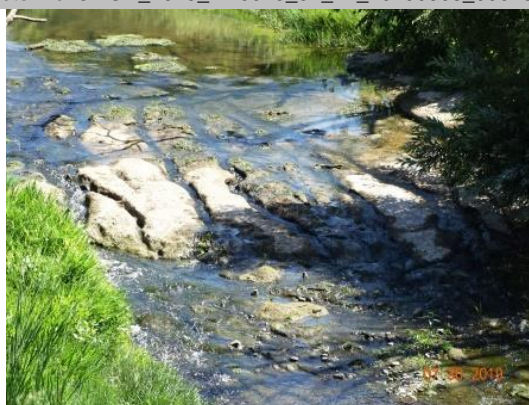
Photo 2 of 3 : CH\_2019\_NA0013\_34\_22\_20190808\_00026.jpg

View of sedimentation on Bear Creek. Summer 2019

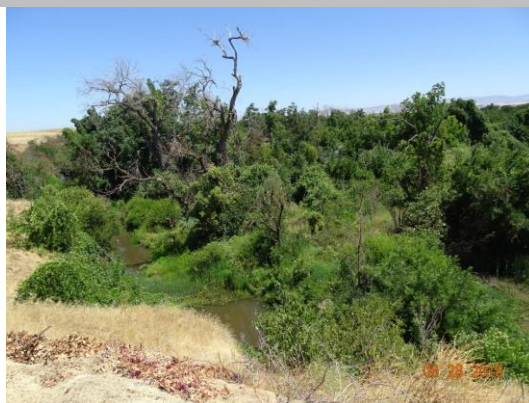
Photo 3 of 3 : CH\_2019\_NA0013\_34\_22\_20190722\_00007.jpg

View of shoal connecting banks of Burns Creek. Summer 2018

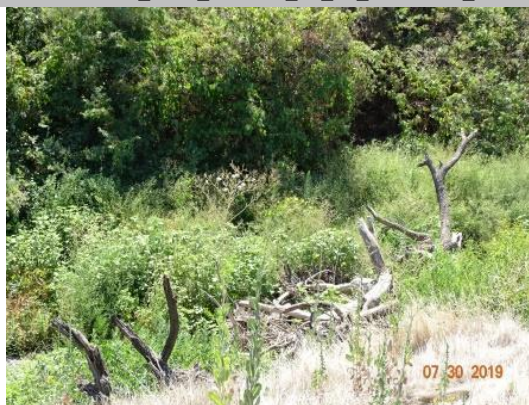
Photo 1 of 1 : CH\_2019\_NA0013\_34\_30\_20190807\_00025.jpg

View of large tree debris on right bank. Summer 2019

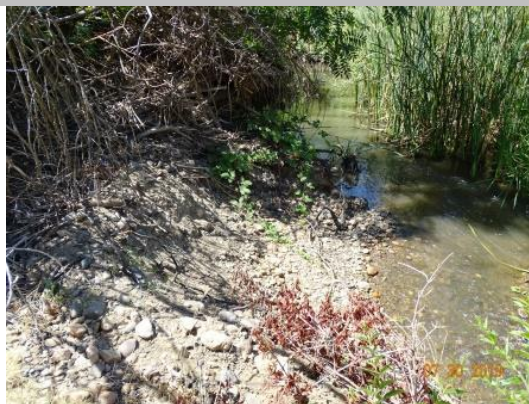
Photo 1 of 1 : CH\_2019\_NA0013\_34\_39\_20190808\_00031.jpg

View of erosion on the left bank. Summer 2019

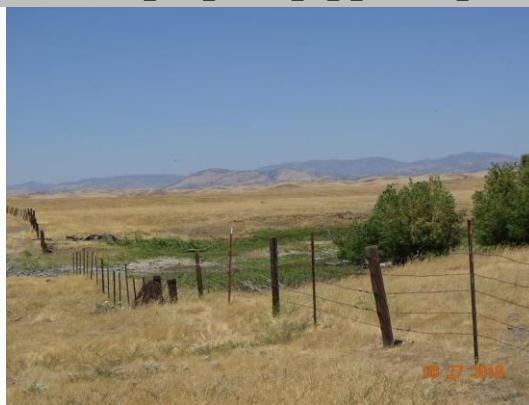
Photo 2 of 2 : CH\_2019\_NA0013\_35\_1\_20190722\_00001.jpg

View of vegetation in channel. Summer 2018

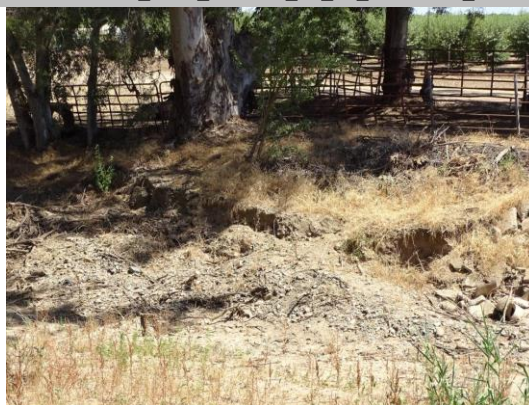
Photo 2 of 2 : CH\_2019\_NA0013\_35\_13\_20190722\_00007.jpg

View of erosion along left bank. Summer 2018

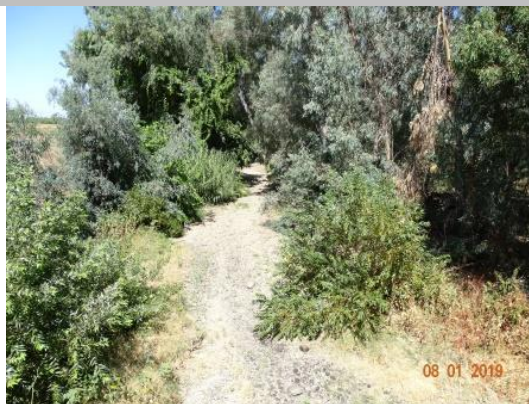
Photo 1 of 3 : CH\_2019\_NA0013\_35\_16\_20190809\_00108.jpg

View of vegetation in the channel. Summer 2019

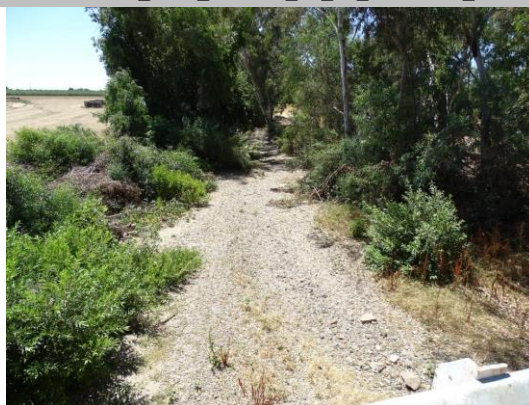
Photo 2 of 3 : CH\_2019\_NA0013\_35\_16\_20190722\_00010.jpg

View of vegetation in the channel. Summer 2018

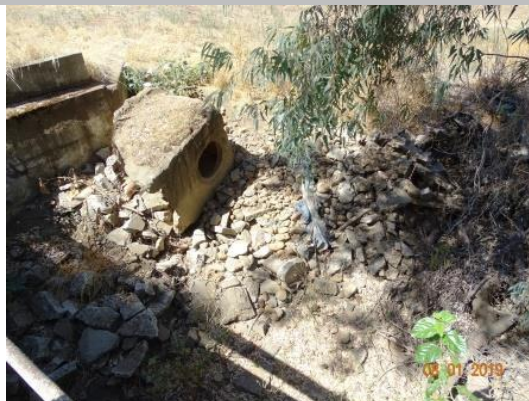
Photo 1 of 1 : CH\_2019\_NA0013\_35\_19\_20190809\_00109.jpg

View of broken concrete riprap on the left bank. Summer 2019

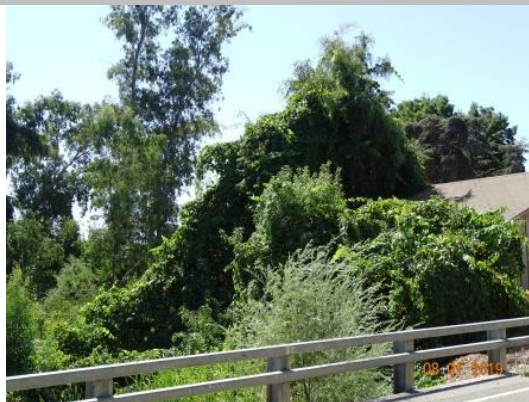
Photo 2 of 3 : CH\_2019\_NA0013\_35\_21\_20190809\_00102.jpg

View of fallen tree with ivy leaning over the building. Summer 2019

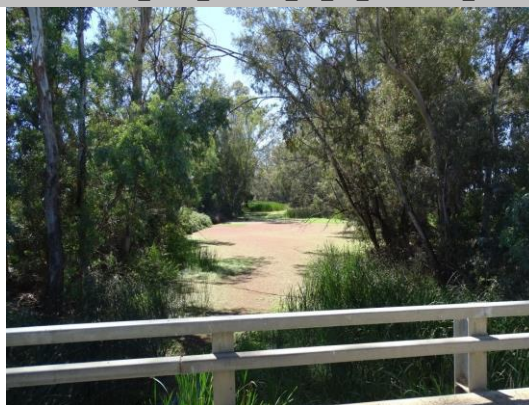
Photo 2 of 2 : CH\_2019\_NA0013\_35\_26\_20190722\_00019.jpg

View of vegetation in the channel. Summer 2018

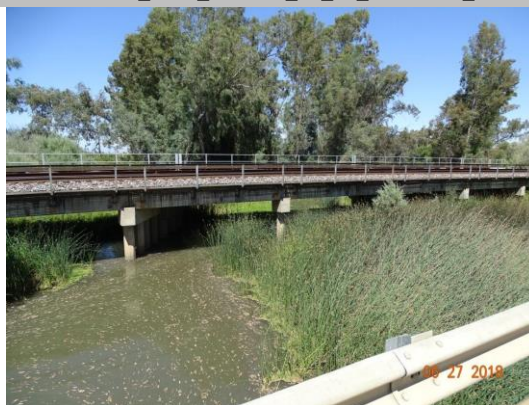
Photo 2 of 2 : CH\_2019\_NA0013\_35\_31\_20190722\_00022.jpg

View of vegetation in the channel. Summer 2018

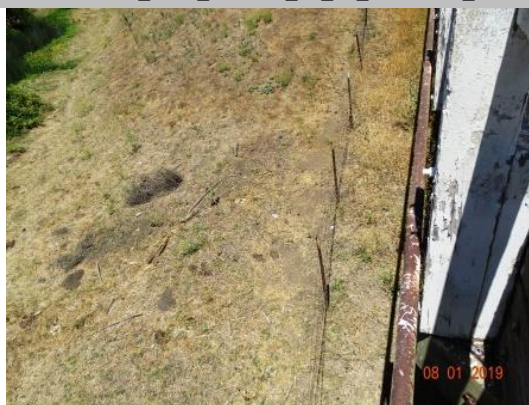
Photo 1 of 3 : CH\_2019\_NA0013\_35\_50\_20190813\_00116.jpg

View of wire fencing across the right bank. Summer 2019

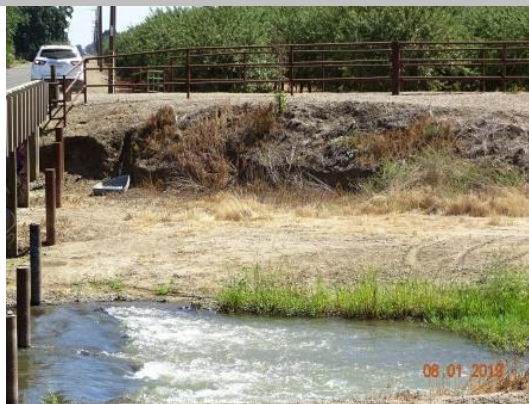
Photo 1 of 2 : CH\_2019\_NA0013\_35\_58\_20190814\_00123.jpg

View of erosion on the left bank. Summer 2019

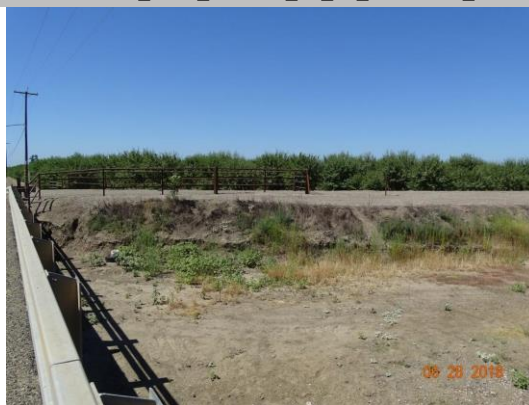
Photo 2 of 2 : CH\_2019\_NA0013\_35\_58\_20190722\_00045.jpg

View of erosion along left bank. Summer 2018

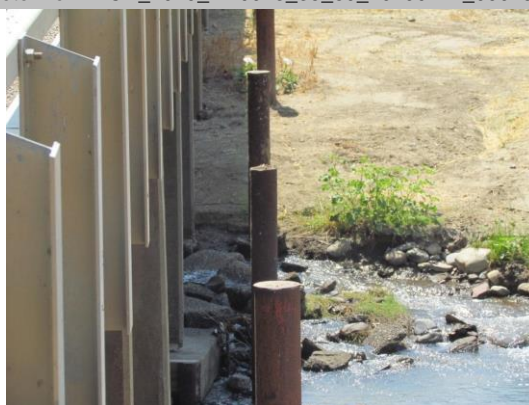
Photo 2 of 2 : CH\_2019\_NA0013\_35\_60\_20190722\_00048.jpg

Another view of the metal post installed across the channel viewed from the right bank. Summer 2017

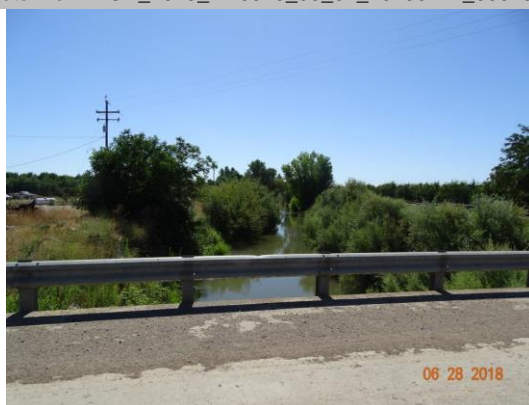
Photo 2 of 2 : CH\_2019\_NA0013\_35\_61\_20190722\_00049.jpg

View of vegetation along banks. Summer 2018

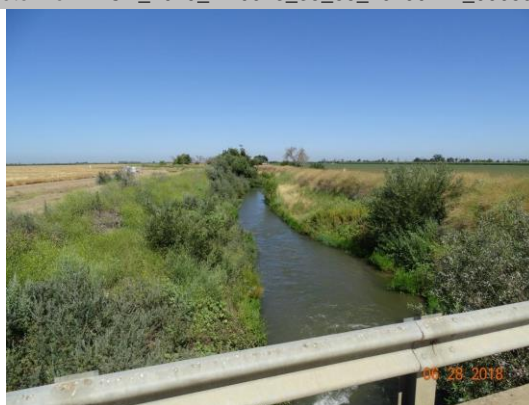
Photo 2 of 2 : CH\_2019\_NA0013\_35\_66\_20190722\_00053.jpg

View of vegetation along banks. Summer 2018

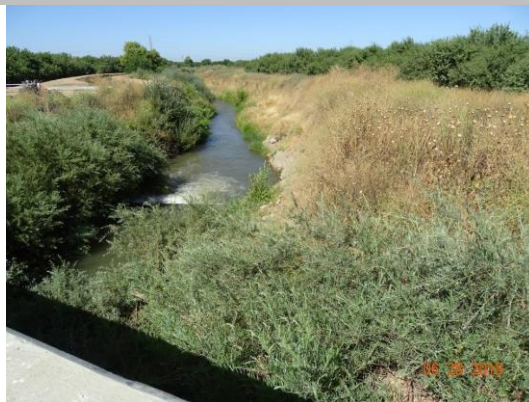
Photo 2 of 2 : CH\_2019\_NA0013\_35\_76\_20190722\_00063.jpg

View of vegetation in the channel and along the banks. Summer 2018

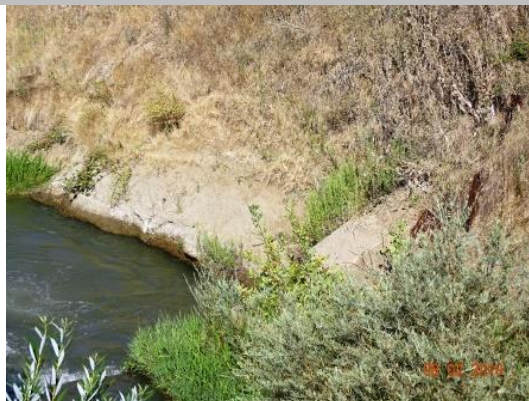
Photo 1 of 4 : CH\_2019\_NA0013\_35\_78\_20190814\_00131.jpg

View of erosion on the right bank. Summer 2019

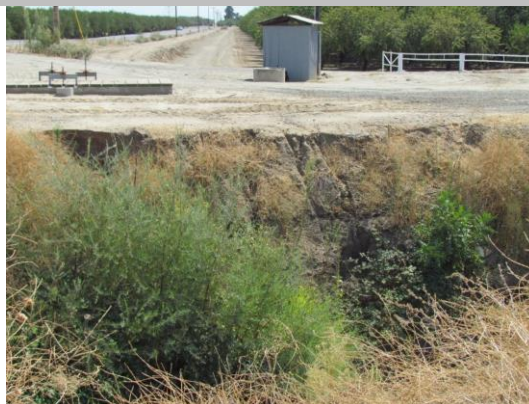
Photo 3 of 4 : CH\_2019\_NA0013\_35\_78\_20190722\_00067.jpg

Looking from the right bank at the erosion on the left bank.

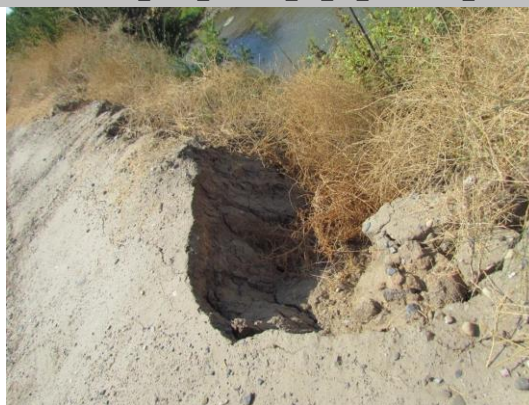
Photo 4 of 4 : CH\_2019\_NA0013\_35\_78\_20190722\_00069.jpg

Looking from left bank at the erosion.

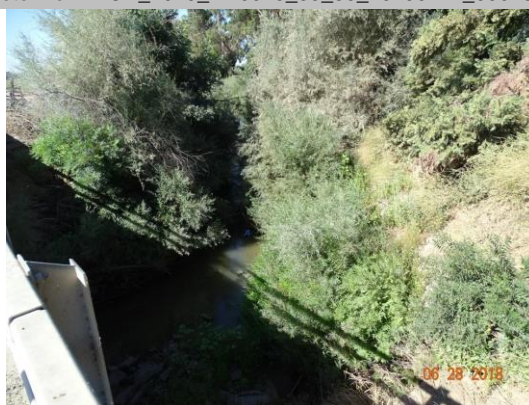
Photo 2 of 2 : CH\_2019\_NA0013\_35\_86\_20190722\_00076.jpg

View of vegetation in the channel and along banks. Summer 2018

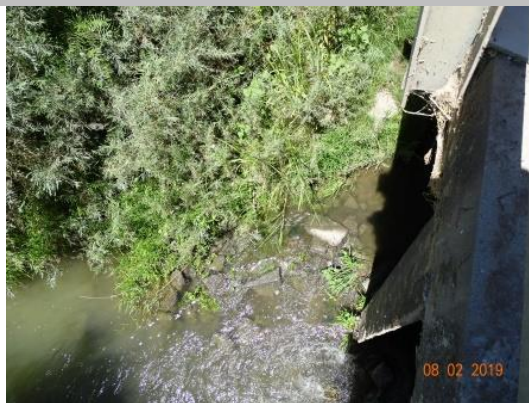
Photo 1 of 2 : CH\_2019\_NA0013\_35\_89\_20190814\_00141.jpg

View of revetment partially covered by vegetation. Summer 2019

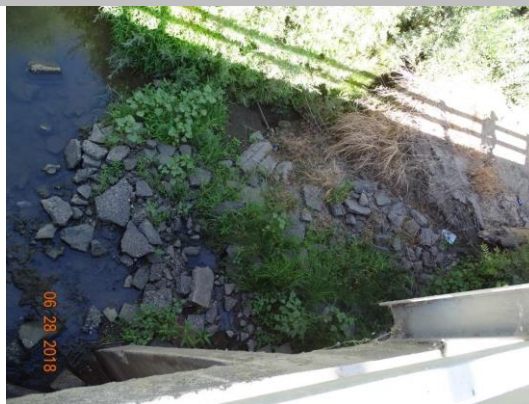
Photo 2 of 2 : CH\_2019\_NA0013\_35\_89\_20190722\_00080.jpg

View of revetment partially covered by vegetation. Summer 2018

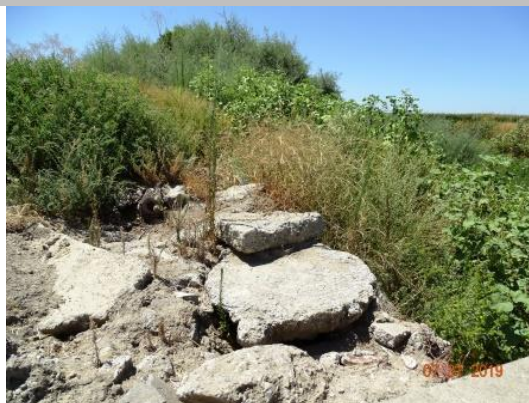
Photo 1 of 2 : CH\_2019\_NA0013\_35\_99\_20190809\_00098.jpg

View of broken concrete riprap on left bank. Summer 2019

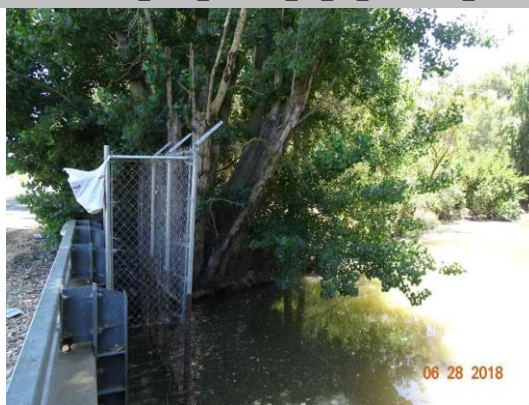
Photo 1 of 2 : CH\_2019\_NA0013\_36\_90\_20190722\_00047.jpg

View of wire fencing on left bank. Summer 2018

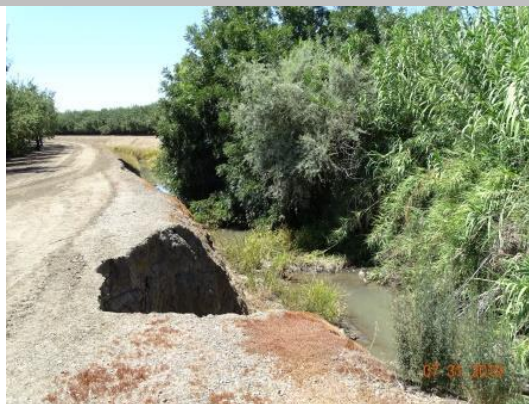
Photo 1 of 3 : CH\_2019\_NA0013\_36\_108\_20190809\_00075.jpg

View of erosion on the left bank. Summer 2019

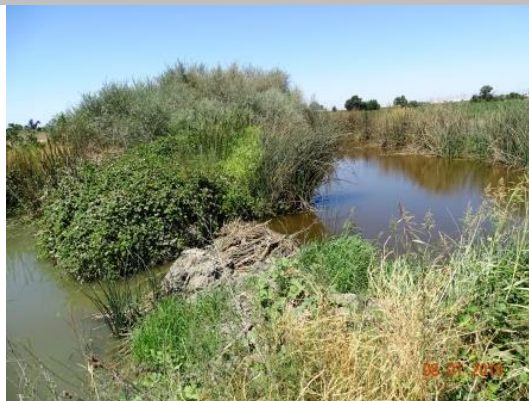
Photo 1 of 2 : CH\_2019\_NA0013\_37\_35\_20190813\_00045.jpg

View of an earth dam placed by a farmer and a possible beaver dam across the channel. Summer 2019
